DAMAGE DETECTION OF SURFACE IN COMPOSITE SHELLS USING MODE SHAPE CURVATURE (MSC) METHOD

ABSTRACT: Importance of having the ability to monitor structural health and detect damage in the fastest possible time is one of the main concerns of engineers, particularly in the fields of mechanical and aerospace. This importance is due to damage in a structure during work can be very severe and sometimes irreparable damages to be followed. One of the methods in this field is the mode shape curvature method. The purpose of this study is located sensitivity methods based on the mode and susceptibility to different intensities of damage in a composite cylindrical shell. The results indicate that this method will capable to recognize 0.08% and over of damage in the total area of the sample.

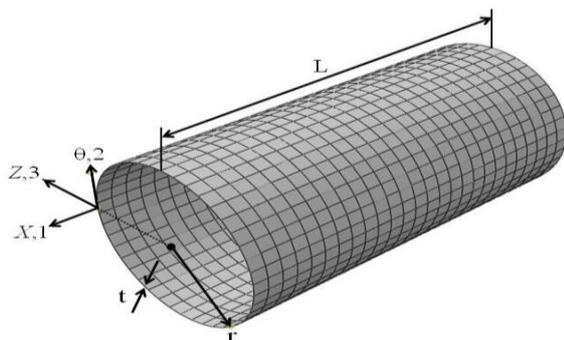
Figure 1: Finite element model of composite cylindrical shell

Before done the experimental tests to validate the process of testing, finite element analysis of composite cylindrical shell made with Abaqus software. The number of elements on convergence of mesh selected that consider the

error less than 0.5%. Nodes in each element have 3 degrees of movement and 3 degrees of rotation. To create an imperfect in the cylindrical shell used the drilling method. After the modal testing procedures and obtained data structures from without imperfection sample, somewhere near the middle of the cylinder at a distance of 35 mm from the center of it (between nodes No. 39,40,51,52) was drilled hole diameter of 4 mm. This hole is equivalent to 0.02% of the total area of sample. In the next steps of testing on the first sample were created 6 and 8 mm diameter defects in the same location and case studies have been done on the imperfections. It is an area of 0.043% and 0.077% of the total area of the sample respectively. For done modal analysis was selected MRIT method and using a hammer for excitation signal. Free - free boundary conditions were studied to do modal tests on cylindrical shells. In general, 84 points was chosen on structure as the excitation. The number of points in the radial direction is 12 and in the longitudinal direction are 7 numbers. These points have been selected based on the structural behavior of various tests. Figure (2), is shown two-dimensional map grid of sample along with the location of accelerometer and create imperfect zone.

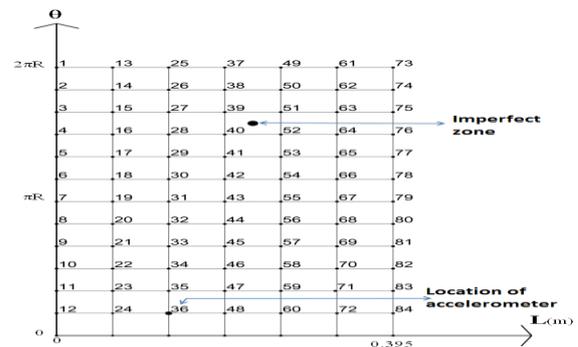
Figure 2: Two dimensional mapped grid of cylindrical sample

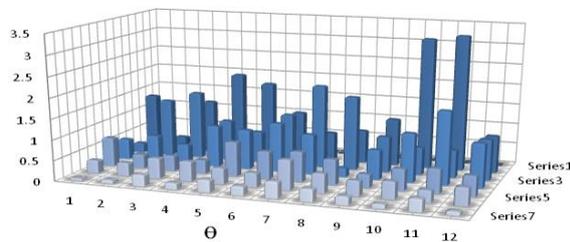
MSC(R) [S1/D=4mm]

Figure 3: The result of defect in first step with mode curvature shape.

In this section obtained the results of modal testing in cylindrical shell and have been located imperfections with method that were described in this study. So, to avoid errors caused by data of mode shape structures the used of the first, third and fifth modes of the structure. The results of this investigation is given in Figures (3) to (5).

Based on results with use the method of mode shape curvature only in the third step of damage that more than 0.08% of the total area of the structural will be able to identify and this research illustrates the precision of the method and limits that can use of it. This method cannot distinguish the imperfections in first and second steps that have 0.02% and 0.04% of the total area of composite cylindrical shell.

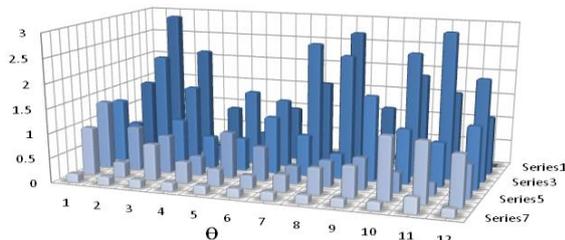
MSC(R) [S1/D=6mm]

Figure 4: The result of defect in second step with mode curvature shape.

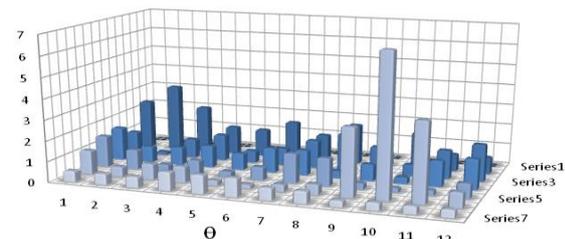
MSC(R) [S1/D=8mm]

Figure 5: The result of defect in third step with mode curvature shape.
